NRL Memorandum Report 6861

High Pressure Turbine Blade Life Extension

H. H. SMITH AND D. J. MICHEL

August 28, 1991

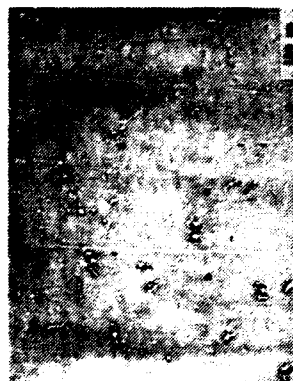
The microstructure of the engine run and new blades is illustrated in Figure 4. This figure compares the microstructure of the blades at two locations along the blade axis. In the mid region of the blades, approximately the mid-point of the length of the blade, the microstructure of all three blades is seen to be similar.

Figure 4. Optical micrographs of new and engine run (not HIP) DS-R80H blades at two locations along the blade axis.

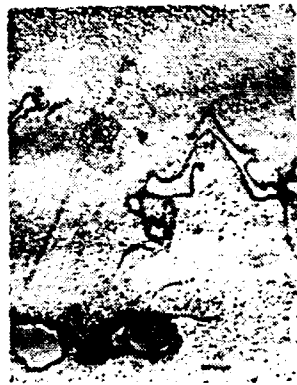
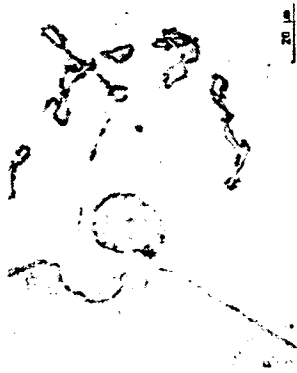
The effect of hot isostatic press (HIP) processing on the microstructure of the new and engine-run blades was investigated. Figure 6 illustrates that the microstructures of the mid region of the HIP processed and not-HIP processed blades was similar for all three blade life conditions examined. However, as shown in Figure 7, the microstructure of the tip region of the not-HIPped low and high EFTC blades have experienced considerable coarsening of the gamma prime precipitate when compared with the microstructure of the new blade in this location. Following HIP processing, all three blades have been restored to a similar microstructural condition.

Figure 6. Optical micrographs of the mid region of HPT blades in new, low hours and high hours engine run conditions for the HIP processed and non-HIP processed conditions.

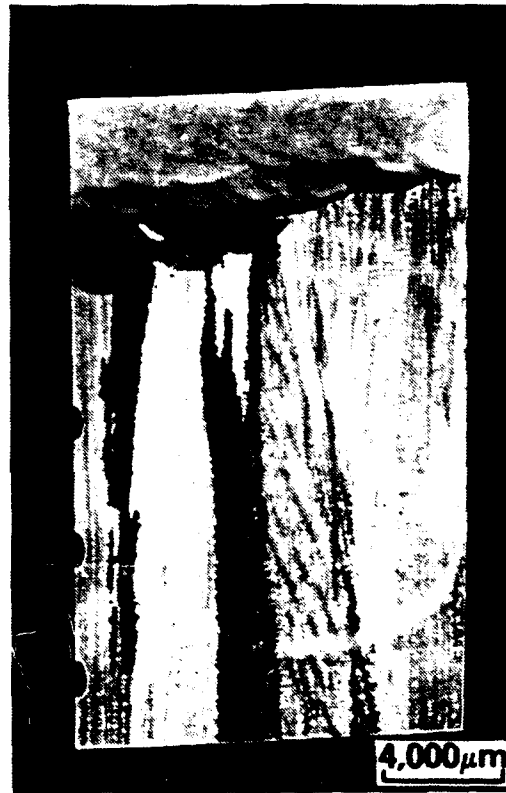
Figure 9 shows the optical microstructure of the interior and exterior surfaces of a DS-R80H blade which has undergone the MERL 72 blade tip repair. Note the appearance of the interface between the directionally solidified grains and the weld deposited material. Figure 10 shows section views of the blade illustrating the well-defined blade-weld interface at several locations. Note the clearly defined interface between the weld and the blade alloy at all sections. However, in sections 2 and 8, small discontinuities originating from the blade interior are clearly visible. These are thought to be associated with oxidation products remaining from the prior engine operation.

Figure 9. Optical micrographs of the interior and exterior surfaces of DS-R80H blades which have received a MERL 72 tip repair.

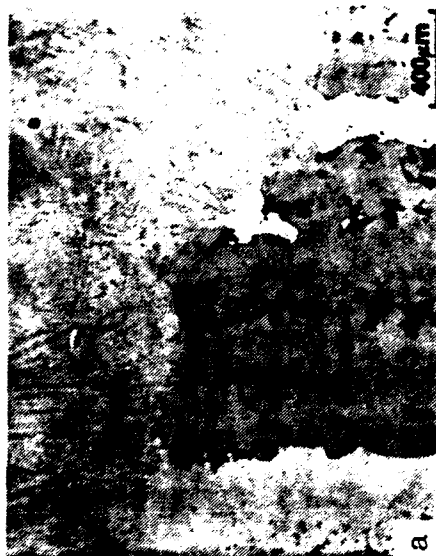
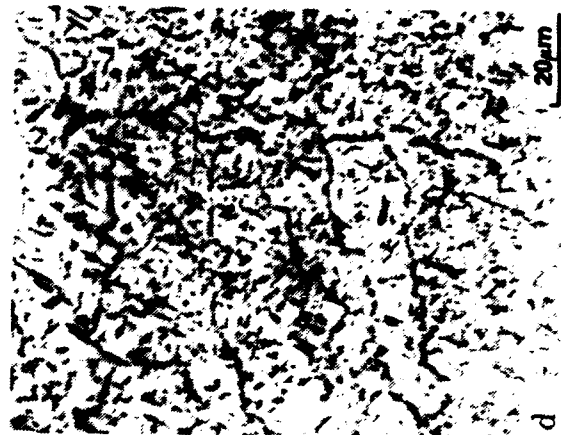
The microstructure of the blade-weld interface is illustrated in the optical micrographs in Figure 11. Figure 11a shows that the weld deposit has formed a porosity-free metallurgical bond with the blade alloy, with minimal dissolution of the blade alloy microstructure. Figures 11(b) through (d) illustrate the microstructures of the blade, weld fusion zone and weld, respectively. In particular, the microstructure of the weld fusion zone shows that minimal dissolution of the blade alloy has occurred during the welding process and that the heat-affected zone was confined to the narrow region near the blade/weld interface.

Figure 11. Optical micrographs of the blade-weld interface.

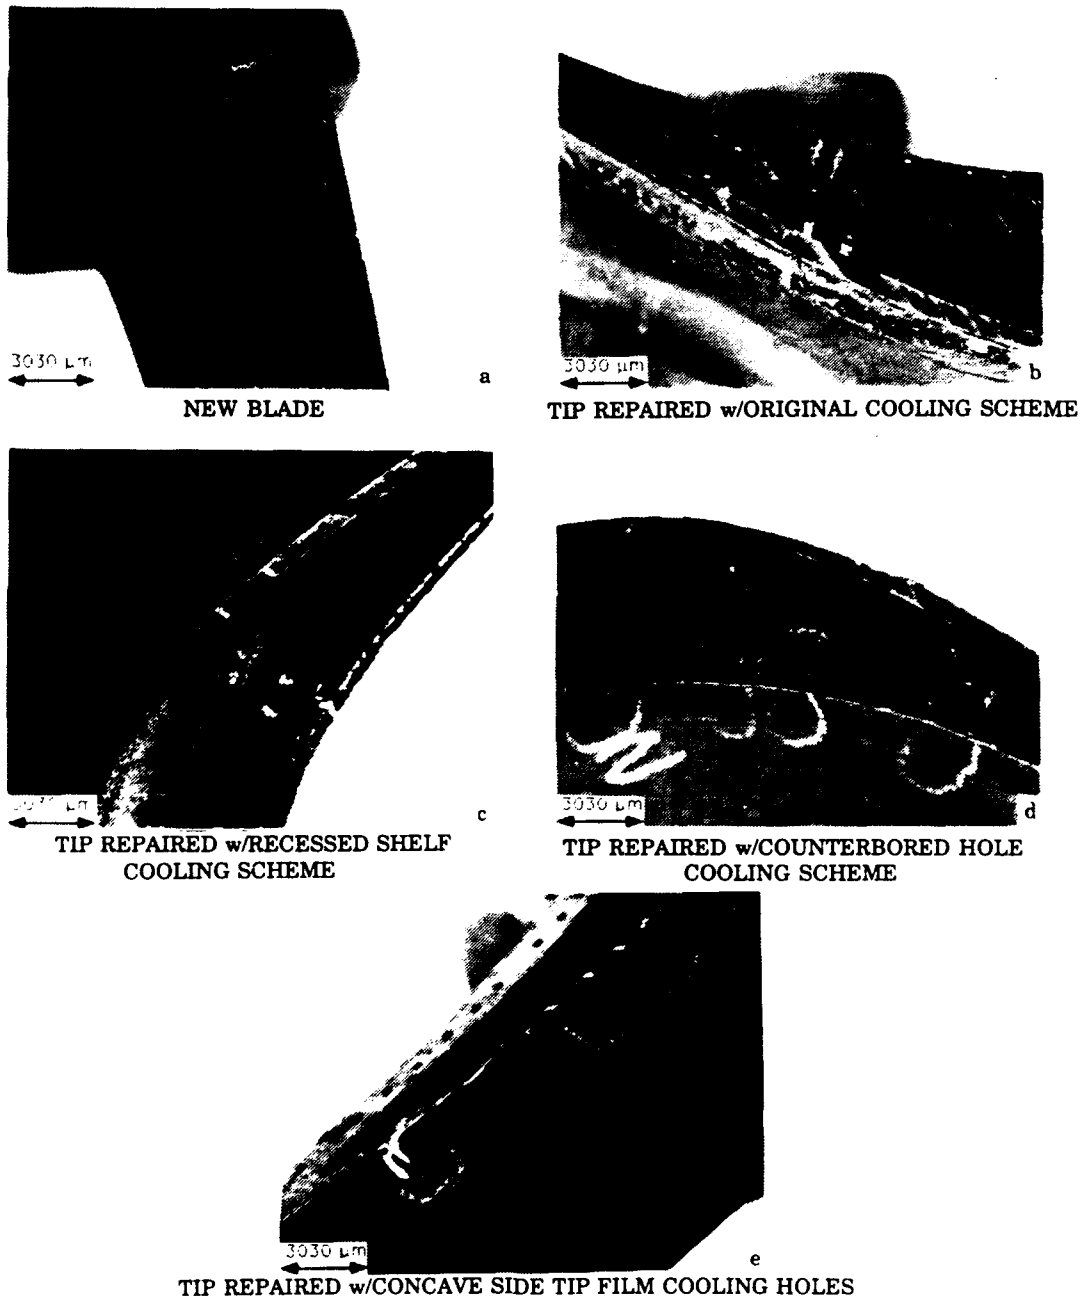
The blade tip regions of the HPT blades which were ASMET engine tested are illustrated in Figure 14. Note the physical condition, especially the trailing edge tip of each blade, which

shows the erosion and/or cracking produced by the ASMET engine test exposure. In particular, note the severe erosion of the blade which was new prior to the engine test and the general lack of erosion of the tip repaired blade with a similar cooling hole configuration.

Figure 14. Trailing edge tip regions of ASMET engine tested, MERL 72 tip repaired, DS-R80H HPT blades.

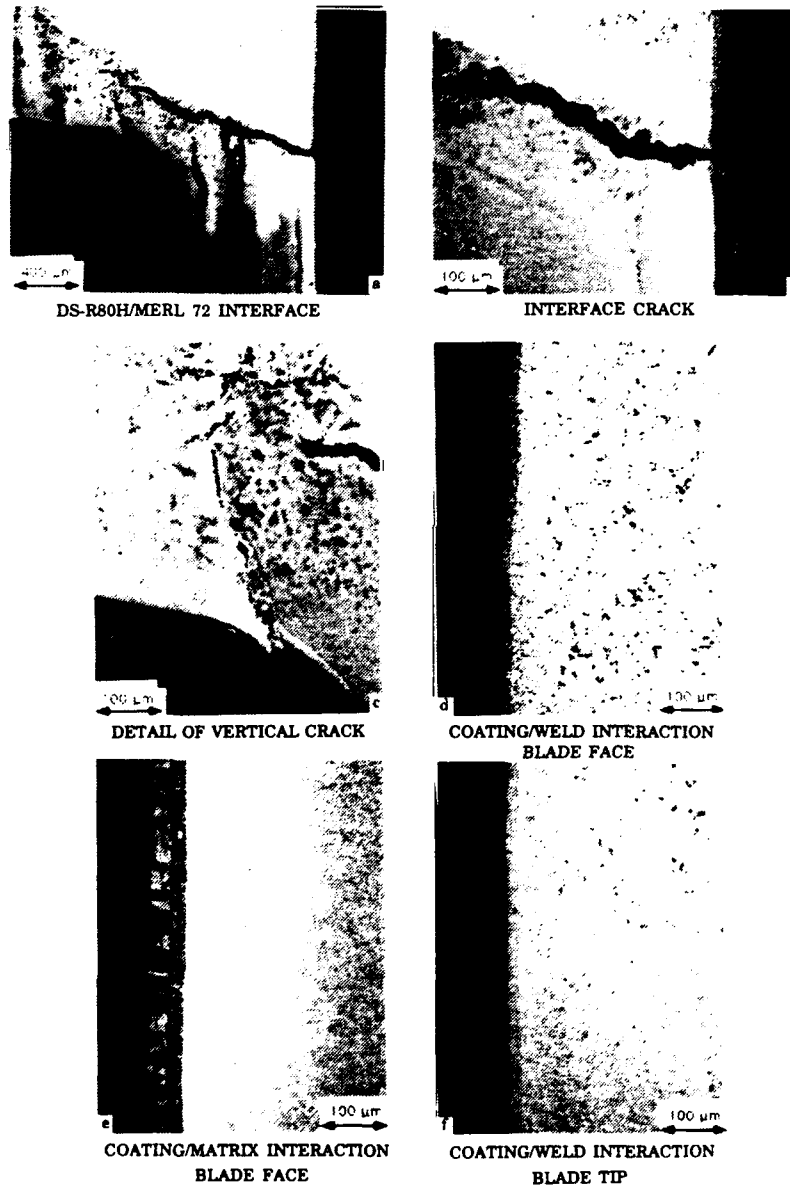
The microstructure of an engine run HPT blade (total EFTC unknown) which was MERL 72 weld tip repaired by Chromalloy Division Oklahoma, configured with the original cooling hole scheme and ASMET engine tested is shown in Figure 16. Figures 16(a) and (b) illustrate a crack which developed at the blade surface which followed the DS-R80H/MERL 72 interface. Figure 16(c) shows the crack tip region and the oxide formed along the entire crack path. Figures 16(d), (e) and (f) illustrate the microstructure of the coating/weld and coating/matrix interactions at various locations on the HPT blade.

Figure 16. DS-R80H HPT Blade, ASMET engine tested, MERL 72 tip repaired by Chromalloy to original tip cooling scheme before engine test.

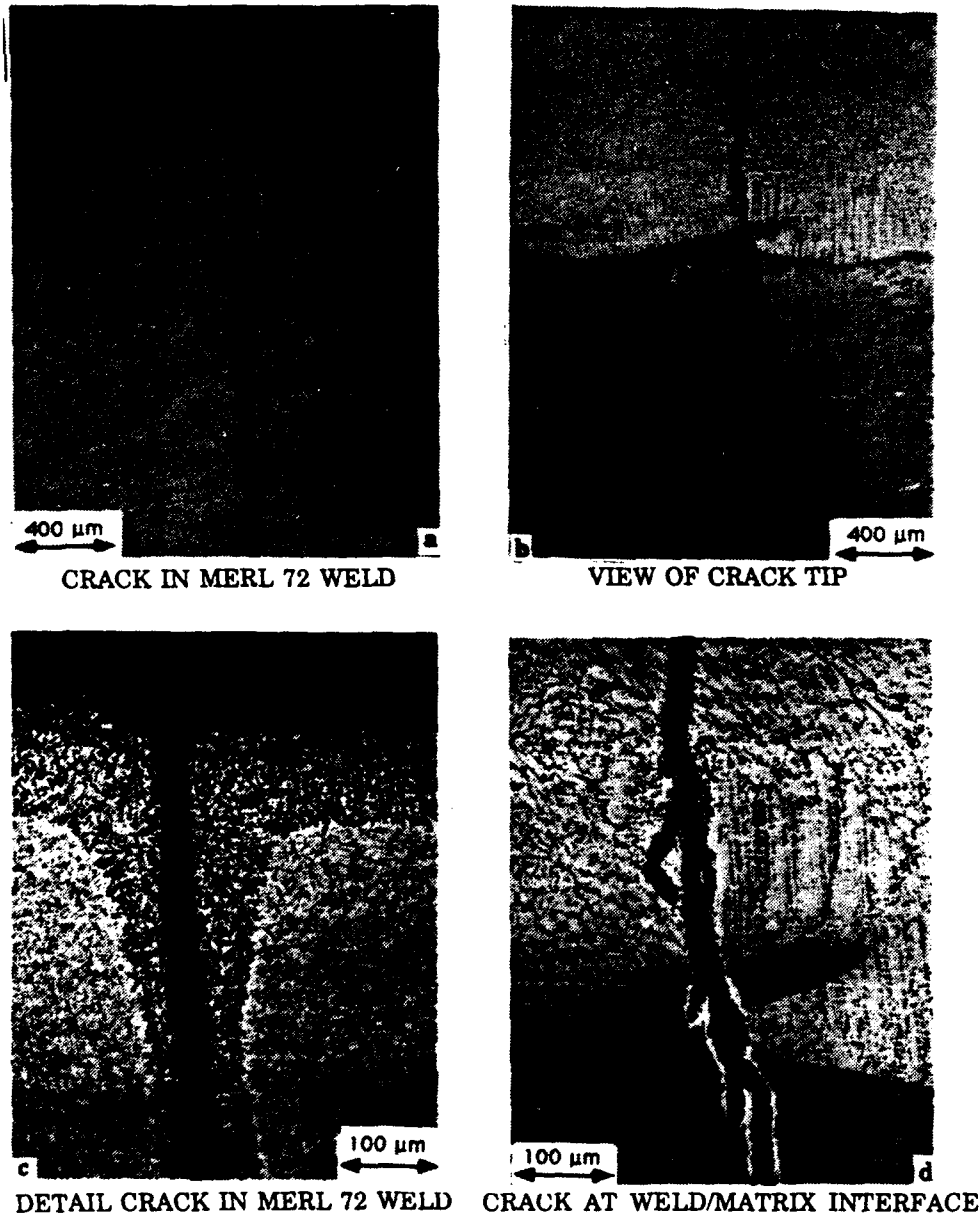
The microstructure of an engine run HPT blade (total EFTC unknown) which was MERL 72 weld tip repaired by Chromalloy Division Oklahoma, configured with a recessed shelf tip cooling scheme and ASMET engine tested is shown in Figure 18. Figure 18(a) illustrates a crack observed in the MERL 72 weld in the vicinity of a cooling hole. Figure 18(b) shows the crack tip region at the DS-R80H/MERL 72 interface. These regions are shown in greater detail in Figures 18(c) and (d). Note the reaction zone formed within the weld along the crack surface and at the top surface of the blade tip, Figure 18(c). Of the four tip configurations examined microstructurally, only the recessed shelf tip cooling hole configuration exhibited this behavior. No differences in microstructure, weld alloy chemistry or coating integrity could be determined which would explain the formation of the reaction zone observed for this blade.

Figure 18. DS-R80H HPT blade, ASMET engine tested, MERL 72 tip repaired by Chromalloy with recessed shelf tip cooling scheme before engine test.

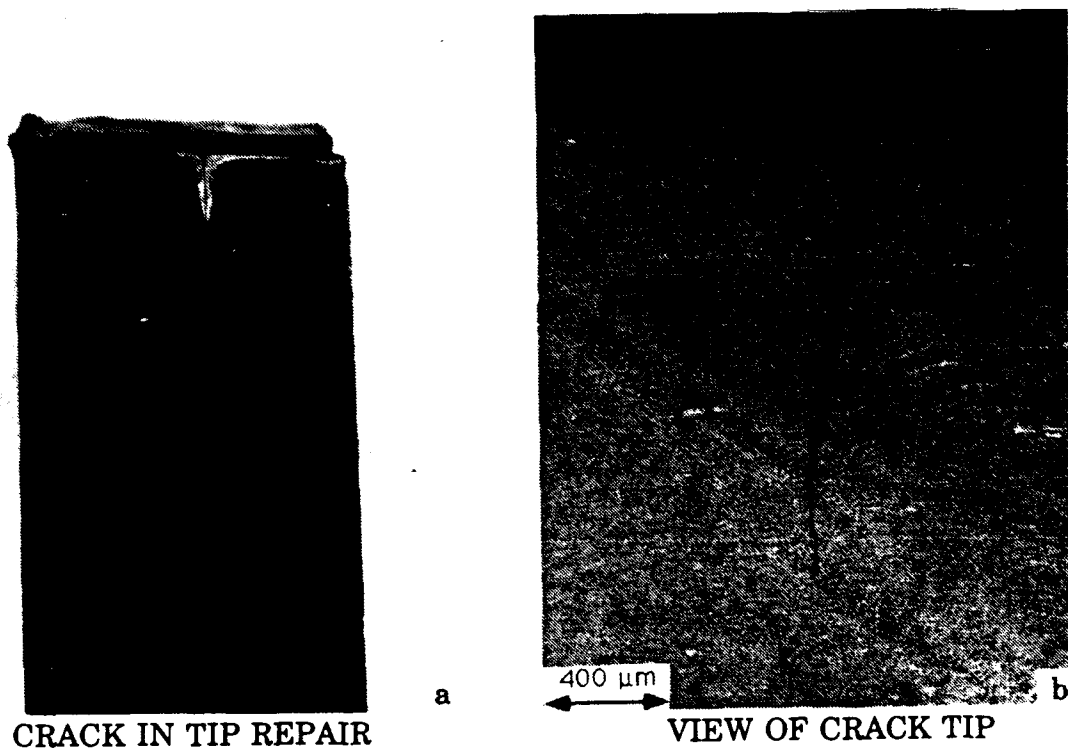
The microstructure of an engine run HPT blade (total EFTC unknown) which was MERL 72 tip repaired by Chromalloy Division Oklahoma, configured with concave side tip film cooling holes and ASMET engine tested is shown in Figure 20. Figure 20(a) illustrates the overall view of a crack associated with a cooling hole. Figure 20(b) illustrates the detail of the crack in the weld built-up blade tip. Fractographs of a crack similar to that shown in Figure 20 are shown in Figure 21. Similar to most blade tip cracks examined, the crack in Figure 21 appeared to initially propagate from the top and outside portions of the blade. The crack then grew as a through-thickness crack, with the crack tip boundary larger on the outside face of the blade.

Figure 20. Photomicrographs of tip cracks formed during the ASMET engine test of a blade repaired with concave side tip film cooling hole scheme.

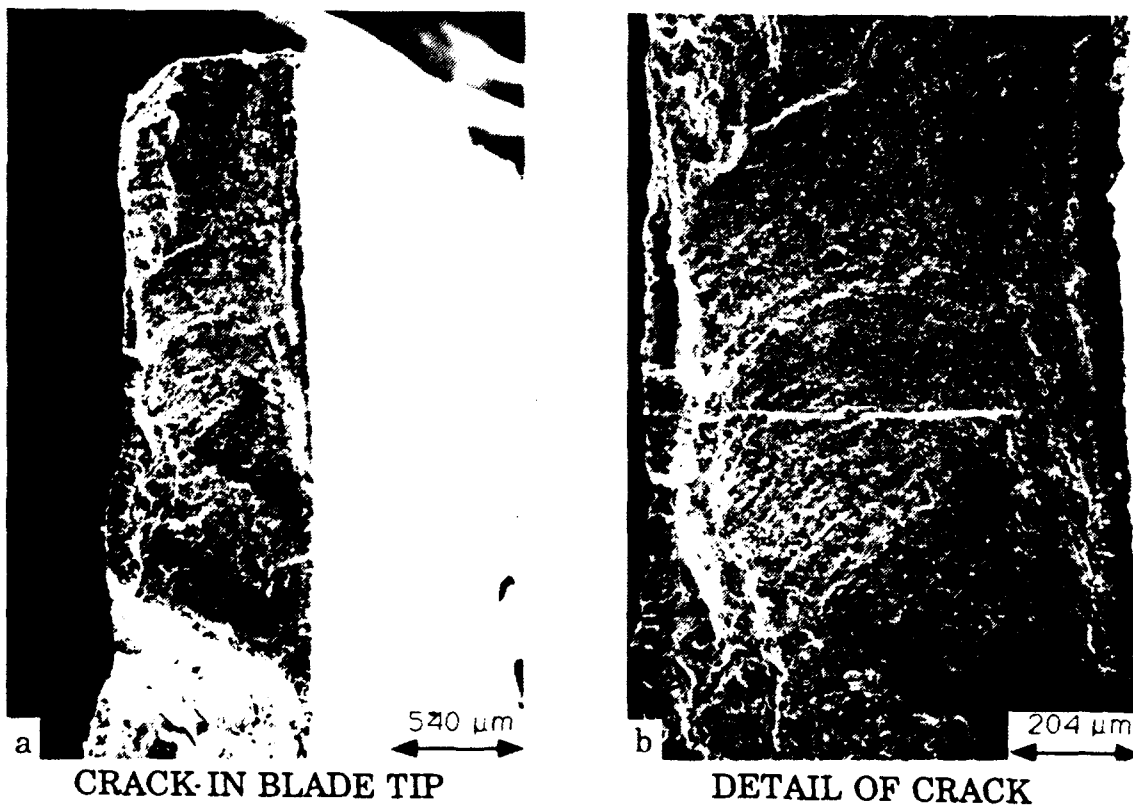
Figure 21. Fractographs of a crack in a DS-R80H HPT blade, ASMET engine tested, MERL 72 tip repaired by Chromalloy with concave side tip film cooling holes before engine test.

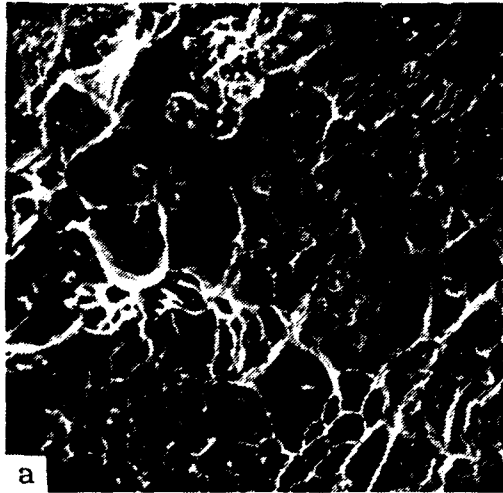
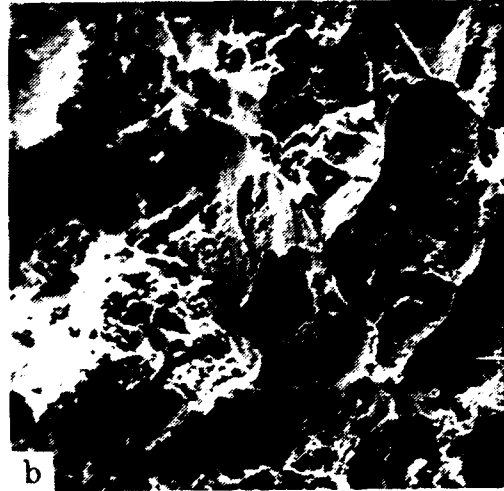
Scanning electron microscopy (SEM) was used to examine the rupture surfaces of the creep/rupture specimens tested in this investigation. SEM micrographs from a specimen tested at 871°C (1600°F), Figures 26(a) and (c), show that both the HIP processed and non-HIP processed specimens failed in a ductile manner by microvoid coalescence. However, for the specimens tested at 982°C (1800°F), the SEM micrographs indicate evidence of surface cracking which linked up to reduce the creep life of the HIP and, to a lesser extent, the not-HIP processed specimens, Figures 26(b) and (d).

Figure 26. Scanning electron micrographs of the DS-R80H creep-rupture specimens tested at 871 and 982°C.
